# Your Inspection Report

3408 Mistwell Cres  
Oakville, ON

RE: Report No. 9205  
3408 Mistwell Cres  
Oakville, ON

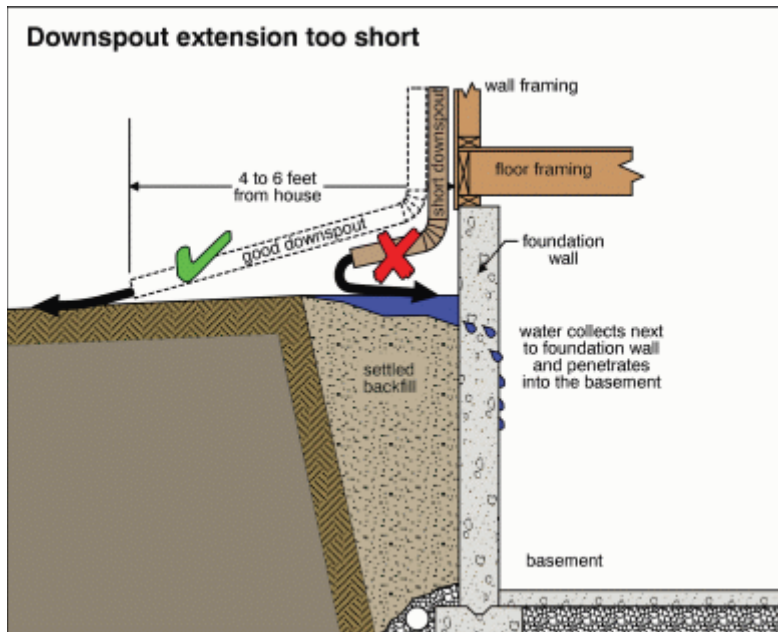
**Condition:** • Downspout ends too close to home. It should direct water at least 6 feet from building.

**Location:** Throughout

**Task:** Improve

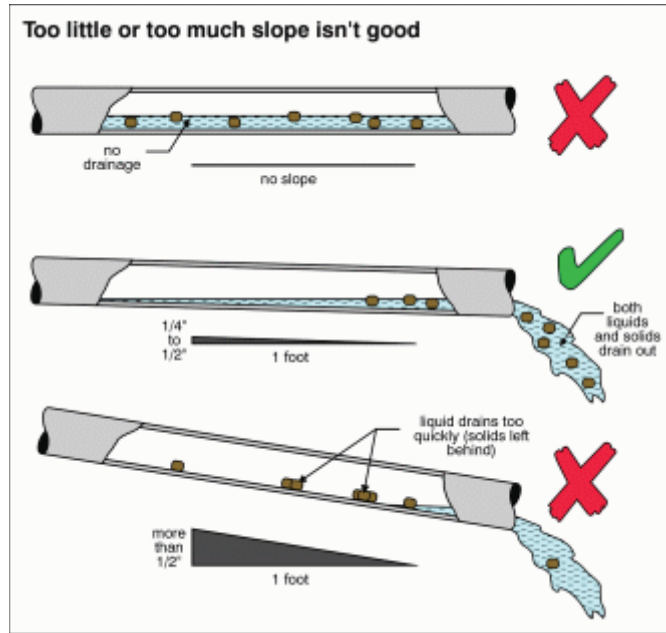
**Condition:** • Slope improper (2.3.2)

**Location:** West Basement

**Task:** Correct
