Your Inspection Report

4 Willrod Rd
Toronto, ON

RE: Report No. 9770
4 Willrod Rd
Toronto, ON

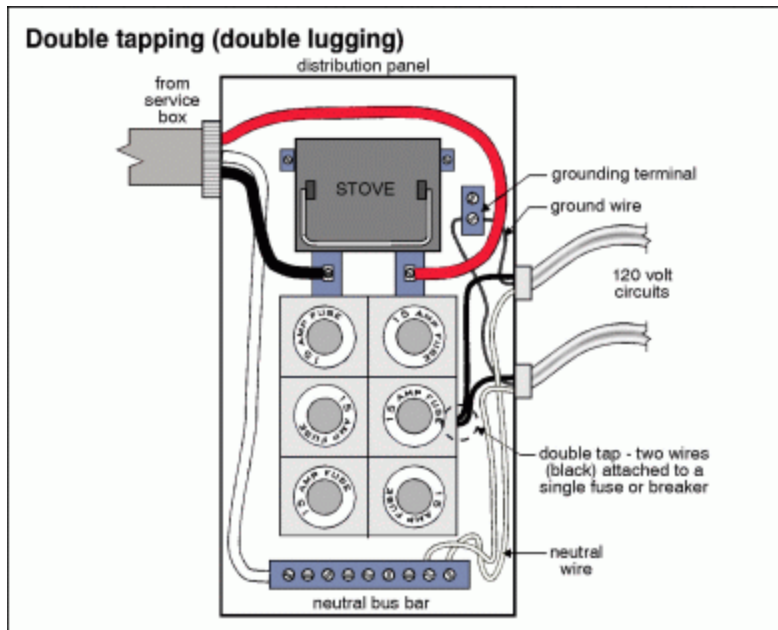
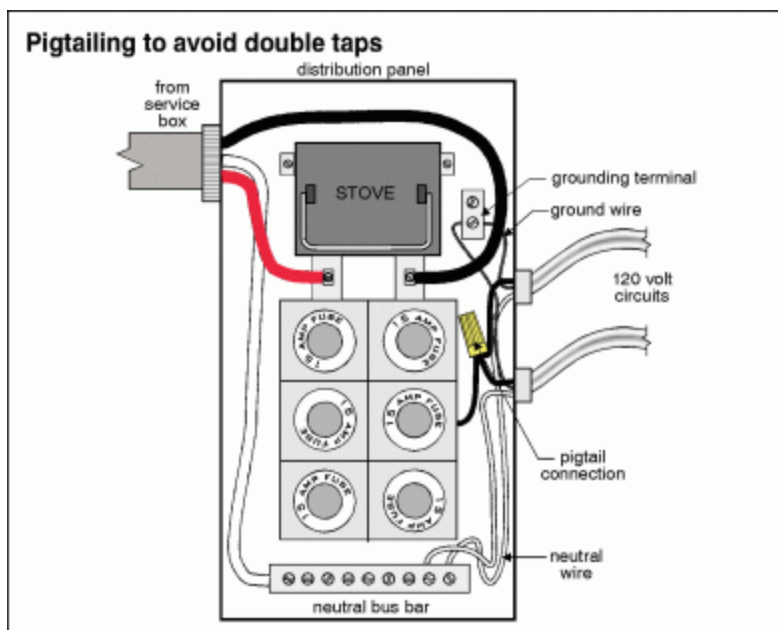
MAIN PANEL - BREAKERS AND FUSES \ 3.3

Condition: • Double tap (two wires on one breaker or fuse)

Task: Correct

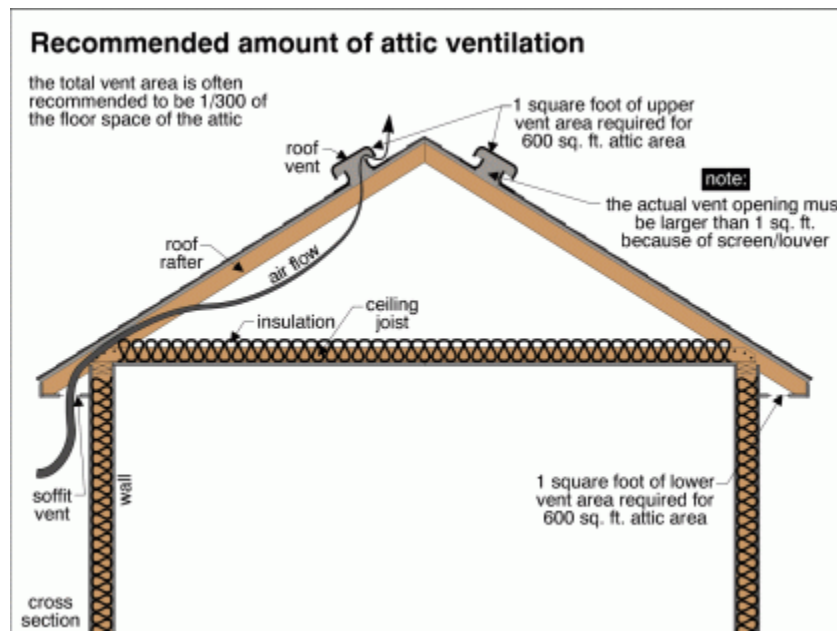
ATTIC \ Ventilation (N, O, 15.0 & 16.0)

Condition: • Ventilation - amount less than ideal

Location: Attic

Task: Improve

Time: When re roofing
