Your Inspection Report

53 Abilene Dr
Toronto, ON M9A 2N2

INSPECTION DATE:
Wednesday, May 12, 2010

Report No. 9597, v.2

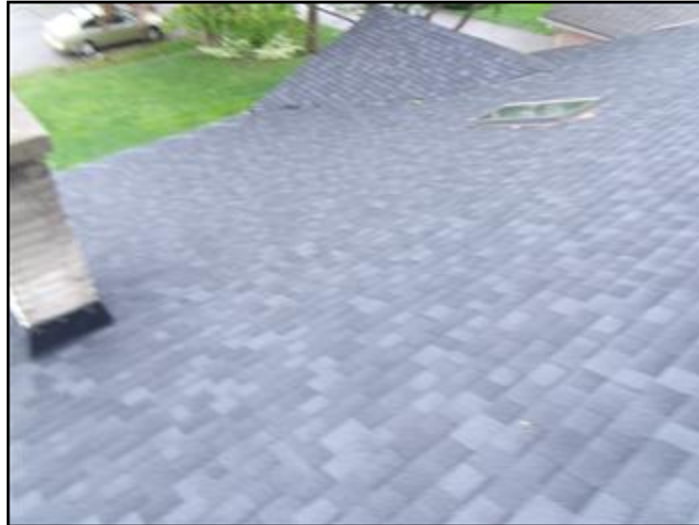
General: • The roof is newer and in good condition.

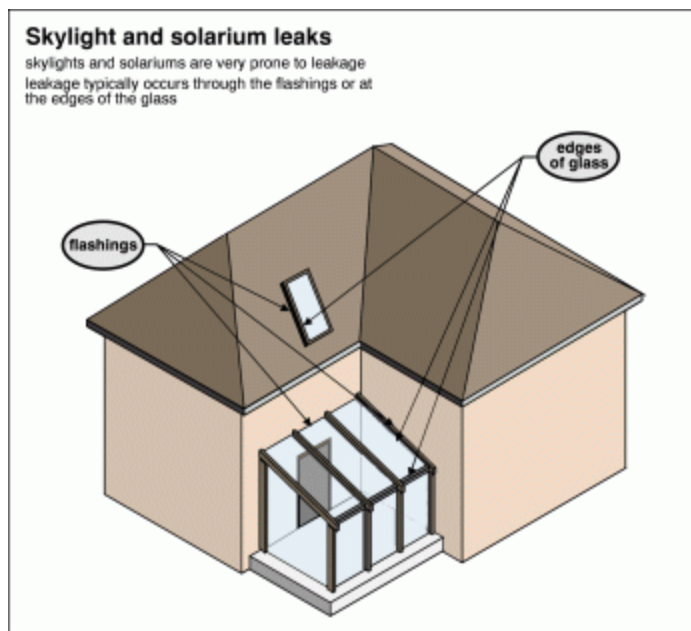
Condition: • [Skylights are vulnerable areas for roof leaks](#)

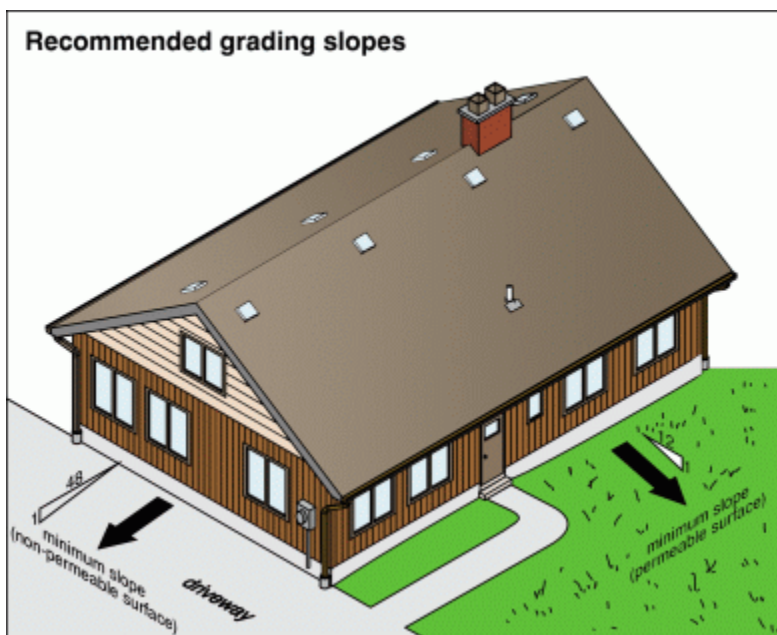
Condition: • [Grading directs water toward house](#)

Location: North Exterior

Task: Correct

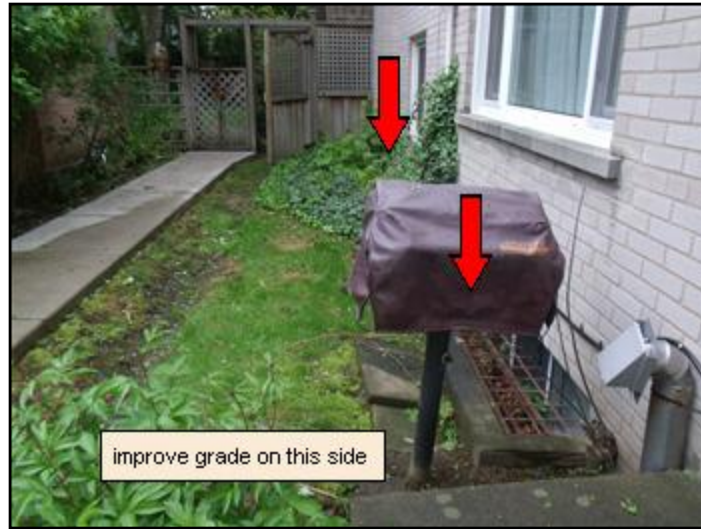
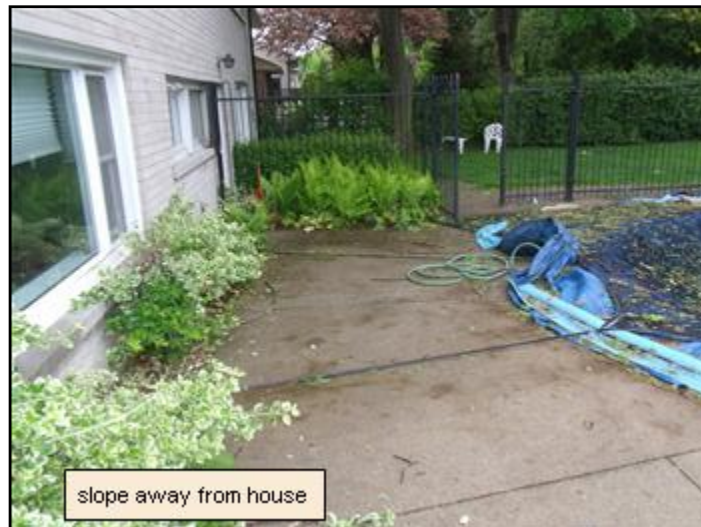
Condition: • [Slope away from house](#)

Location: Rear Yard

Task: Correct

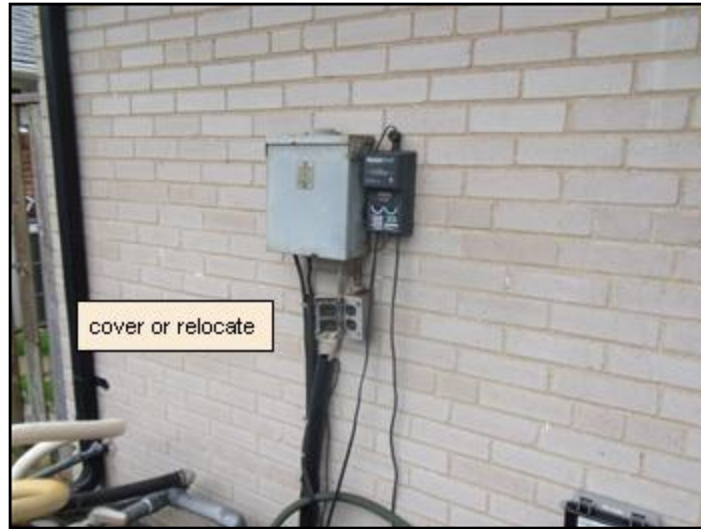
Condition: • [Location poor](#)

Location: Rear Exterior

Panel is prone to corrosion, consider relocating into garage or build a shed around the panel outside.
